MUNOZ INSPECTION SERVICES / TRUSTED TERMITE CONTROL

JUNE 20, 2022

SUMMARY

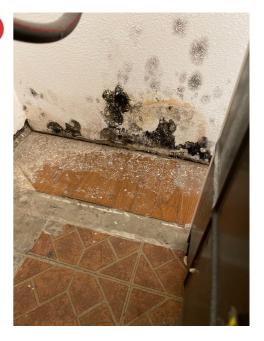
1.1.1 Potential Concerns

MOLD

UTILITY ROOM

Microbial growths were found at one or more locations in *interior rooms / the attic / the crawl space / the basement / the garage*. It is beyond the scope of this inspection to identify what substance or organism this staining is. However such staining is normally caused by excessively moist conditions, which in turn can be caused by plumbing or building envelope leaks and/or substandard ventilation. These conducive conditions should be corrected before making any attempts to remove or correct the staining. Normally affected materials such as drywall are removed, enclosed affected spaces are allowed to dry thoroughly, a mildewcide may be applied, and only then is drywall reinstalled. For evaluation and possible mitigation, consult with a qualified industrial hygienist or mold/moisture mitigation specialist. For more information, visit:

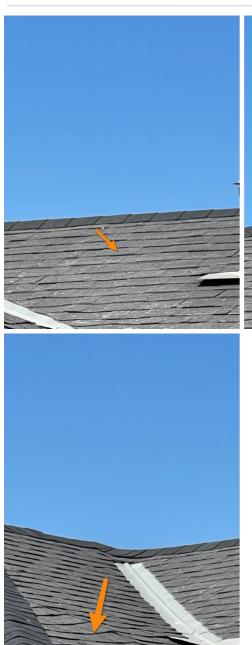
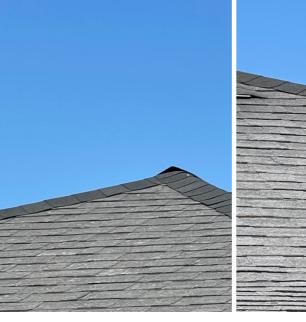
3.1.1 General

NEEDS REPAIR

Roof covering showing signs of curling, cracking, loose, split Shingles, slipped tiles recommend a licensed roofing contractor to further evaluate roof covering.

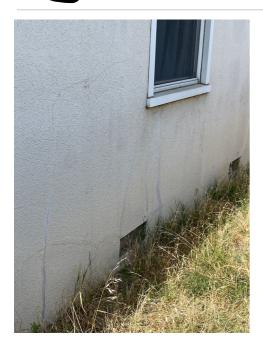
4.1.2 Exterior Walls / Trim

MINOR EXTERIOR STUCCO CRACKS.

Stucco cracks occur when house settles and or stucco cures this is no more than a cosmetic issue recommend to sill stucco cracks with caulking and or exterior paint.

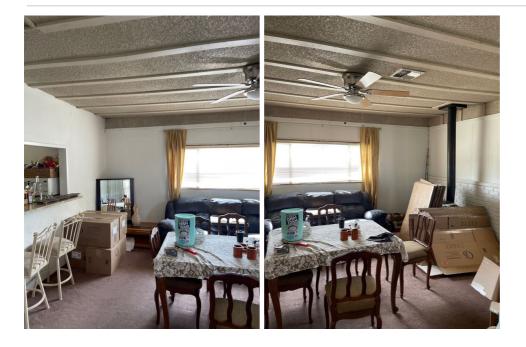
GARAGE WAS CONVERTED INTO A LIVING QUARTERS.

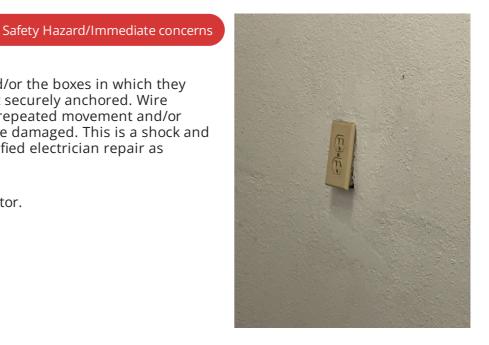
LOOSE

One or more electric receptacles and/or the boxes in which they were installed were loose and/or not securely anchored. Wire conductors can be damaged due to repeated movement and/or tension on wires, or insulation can be damaged. This is a shock and fire hazard. Recommend that a qualified electrician repair as necessary.

Contact a qualified electrical contractor.

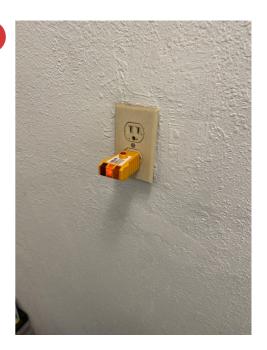
OPEN GROUND - REWIRE OR REPLACE WITH 2-SLOT

UTILITY ROOM

One or more modern, 3-slot electric receptacles were found with an open ground. Three-slot receptacles should have a hot, a neutral and a ground wire connected. Homeowners often install new 3-slot receptacles on older, 2-wire circuits that only have hot and neutral wires. This is a shock hazard when appliances that require a ground are used with these receptacles. Examples of such appliances include computers and related hardware, refrigerators, freezers, portable air conditioners, clothes washers, aquarium pumps, and electrically operated gardening tools. Where the electric system was installed prior to when grounded circuits were required (1960s), it is permissible to replace 3-slot receptacles with 2-slot receptacles to prevent appliances that require a ground from being plugged in to an ungrounded circuit. However, the client should be aware of this limitation when planning use for various rooms, such as an office. For newer electric systems, circuits should be repaired so grounded, 3-wire cables provide power to 3-slot receptacles. Recommend that a qualified electrician repair per standard building practices.

Contact a qualified electrical contractor.

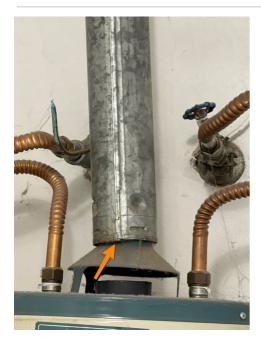
MISSING FASTENERS

Water heater flue pipe needs to be properly fastened with metal screws and all joints should be wrapt with temperature rated tape.

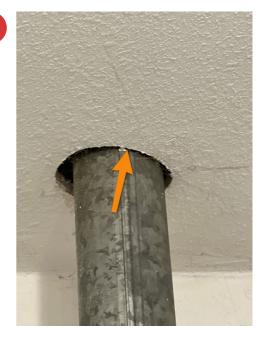
10.8.2 Flues

MISSING VENT FLANGE TO WATER HEATER FLUE.

Safety Hazard/Immediate concerns

Vent flue is in direct contact with combustible material.

Recommend installing vent flange to water heater, this is considered a safety concern.

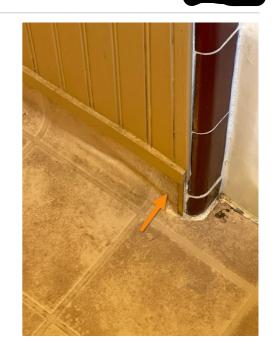
Vinyl flooring in bathroom was damaged / deteriorated / loose / curling. Water can damage the the sub-floor as a result. Recommend that a qualified contractor replace or repair flooring as necessary.

Contact a qualified professional.

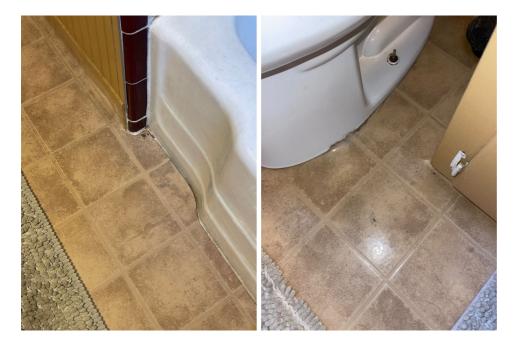
12.3.2 Floors

SOFT SPONGY FLOOR POSSIBLE WATER DAMAGE.

See termite inspection report for any recommendations

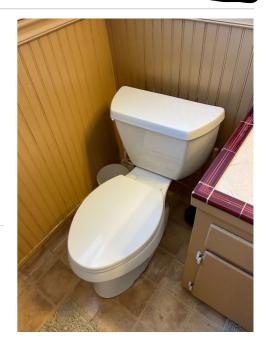
12.5.1 Toilets

LOOSE, EVAL, REPAIR

The toilet was loose where it attached to the floor. Leaks can occur. Flooring, the sub-floor or areas below may get damaged. Sewer gases can enter living spaces. Recommend that a qualified contractor remove the toilet(s) for further evaluation and repair if necessary. A new wax ring should be installed and toilet(s) should be securely anchored to the floor to prevent movement and leaking.

Contact a qualified professional.

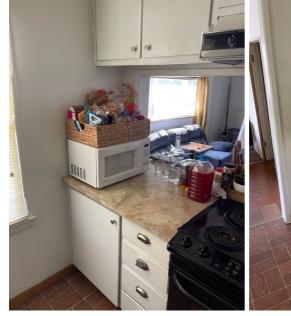
Counters

KITCHEN COUNTER NOT FULLY INSPECTED DO TO OWNERS STORAGE

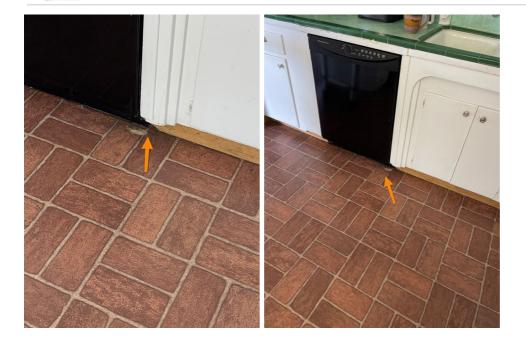
WORN DAMAGED VINYL FLOOR

Contact proper trades person to further evaluate and repair or replace as necessary and if desired.

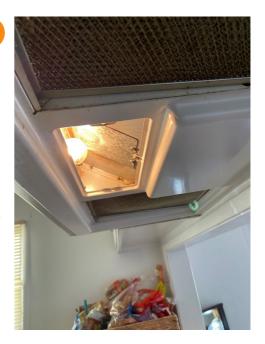
13.8.1 Ventilation

HOOD LIGHT - INOPERABLE / OR MISSING LIGHT COVER

The light in the exhaust hood was inoperable / or light cover missing Recommend replacing light bulb(s) or light cover. that repairs be made by a qualified person if necessary.
